# Manhole Inspection Summary

Manhole # S45GG\_051MH

Insp Date: **2/4/10 2:08 PM**

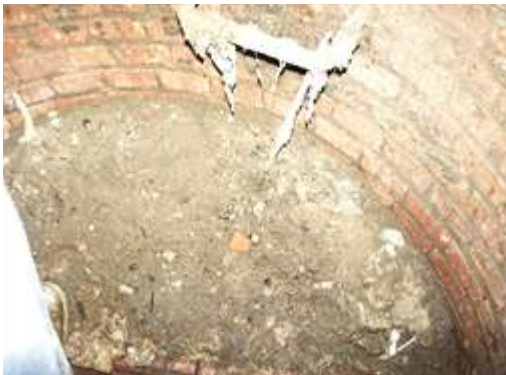
Defect 1

Condition: ☐ Sound ☐ Cracked ☐ Root Intrusion ☐ Deteriorated ☐ Leaks ☒ **Debris**

debris

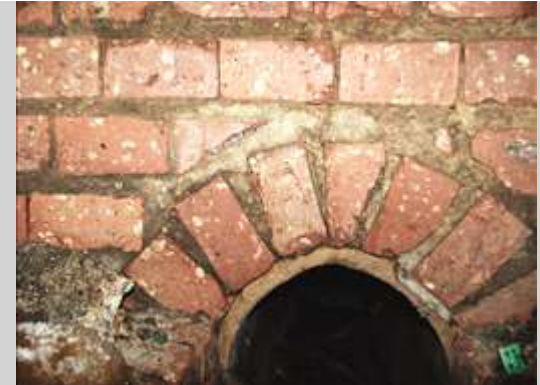
12 O'Clock Outflow

8 in. Circular Gravity Sewer  
Pipe Out @ 12 O'Clock

Pipe Height: **8.4** (in.) Rod and Bar (Angled)  
Pipe Material: **Clay** ☐ Pipe Lined  
Invert Depth: **8.75** (ft.) Flow Characteristics: **Slow**  
Deposits: ☒ None ☐ Mud ☐ Sludge ☐ Debris ☐ Grease  
Silt Depth: (in.) Deposits Extent:  
Infiltration: **None** Pipe Seal Cond: **Sound**

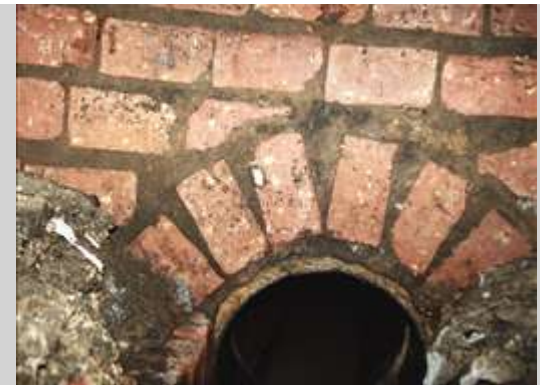
6 O'Clock Inflow

8 in. Circular Gravity Sewer  
Pipe In @ 6 O'Clock

Pipe Height: **8.4** (in.) Rod and Bar (Angled)  
Pipe Material: **Clay** ☐ Pipe Lined  
Invert Depth: **8.58** (ft.) Flow Characteristics: **Slow**  
Deposits: ☒ None ☐ Mud ☐ Sludge ☐ Debris ☐ Grease  
Silt Depth: (in.) Deposits Extent:  
Infiltration: **None** Pipe Seal Cond: **Sound**

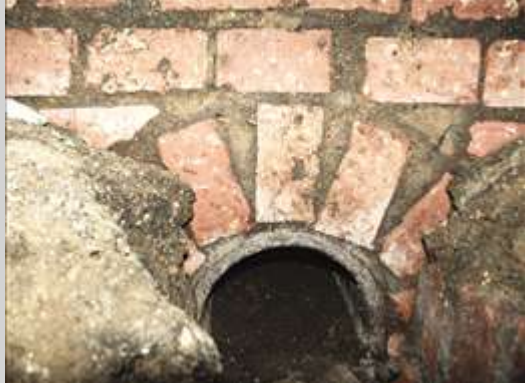
9 O'Clock Inflow

8 in. Circular Gravity Sewer  
Pipe In @ 9 O'Clock

Infiltration: **None**

Pipe Seal Cond: **Sound**
